# A Report On Preliminary Investigating Of The Structural Condition Of The Chandeshwari Temple-Banepa-Nepal

( July 1983 )

— John Sanday

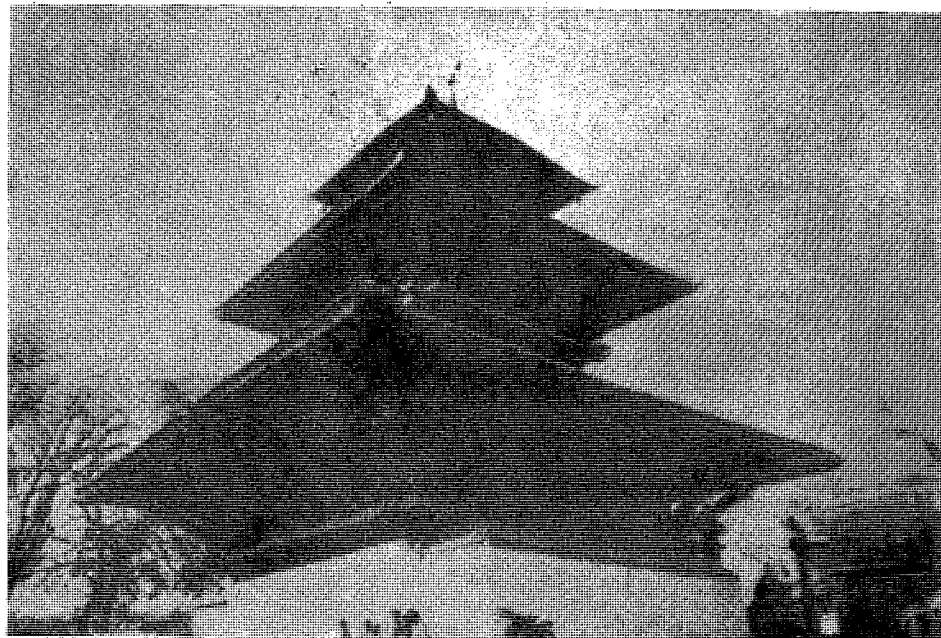
It is fairly certain that the Eastern single storeyed addition was added after the completion of the temple, probably to enlarge the sanctum. This addition however, takes part of the inner structure without any recognizable alternation in order to hold up the upper structure.

*View from the South showing the single storied addition*

The one storeyed addition, which enlarges the sanctum to the East needs another roof in order to match with the adjacent wall of the temple. The woodcarving of both windows and struts will be cleaned of paint and grime, repaired where necessary and treated against fungal and beetle attack. The facing brickwork needs to be cleaned and repaired and any defective bricks will be replaced with new matching bricks.

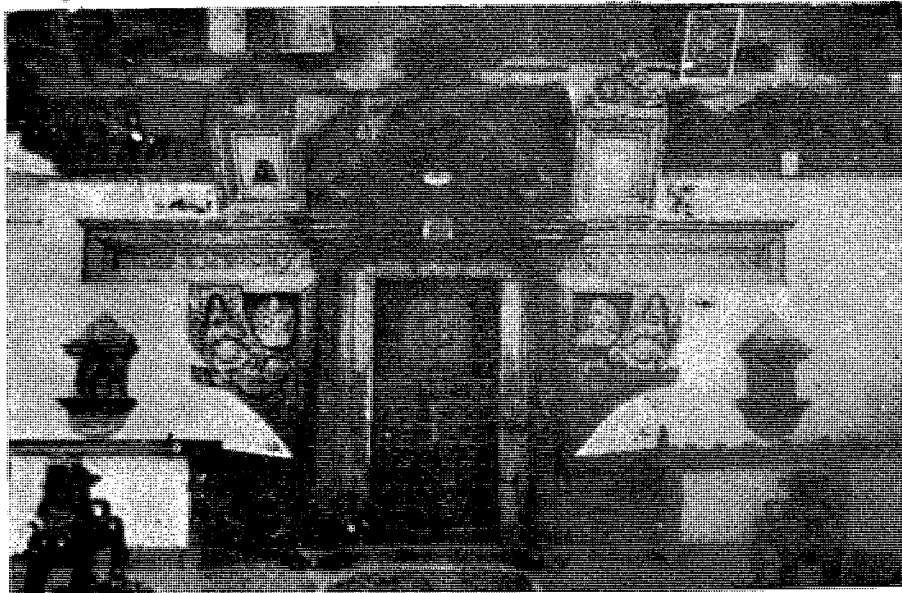
*Entrance to the Chāndeshwari Temple*

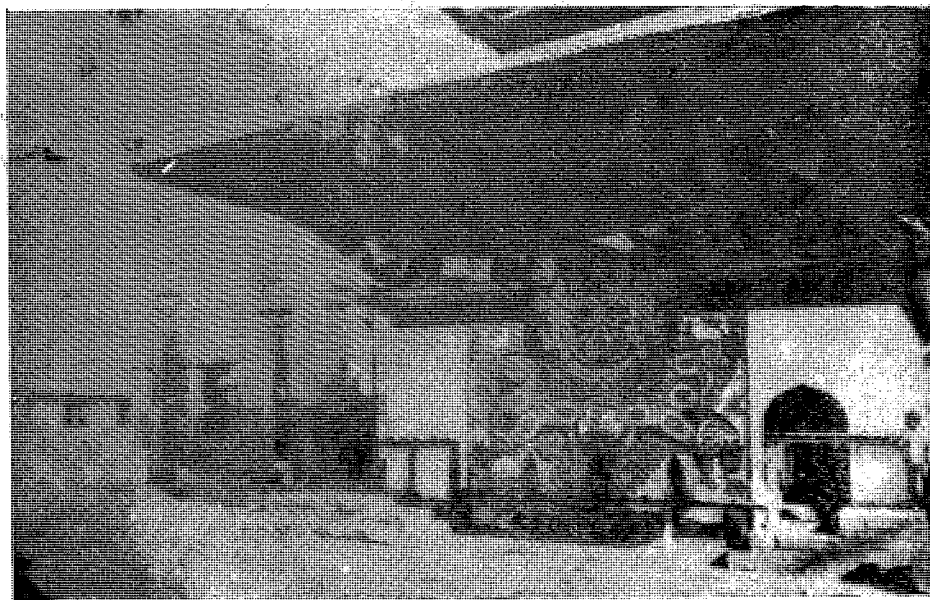
The multi-coloured fresco which is painted on a layer of plaster, is been pushed off the wall at the top while at the bottom due to rising damp and the leak of a plinth, the paint is been washed away.

*Giant mural of Bhairab on the Eastern wall*

The multi-coloured fresco needs careful repair. The clay on which the fresco is painted is being pushed away from the wall and needs to be repaired. A damp-proof course at the bottom of the fresco will prevent further rising damp.

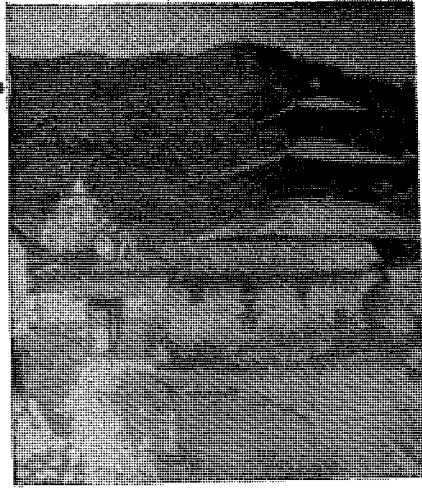
*Main entrance to the temple  
precinct — 1975 A. D.*

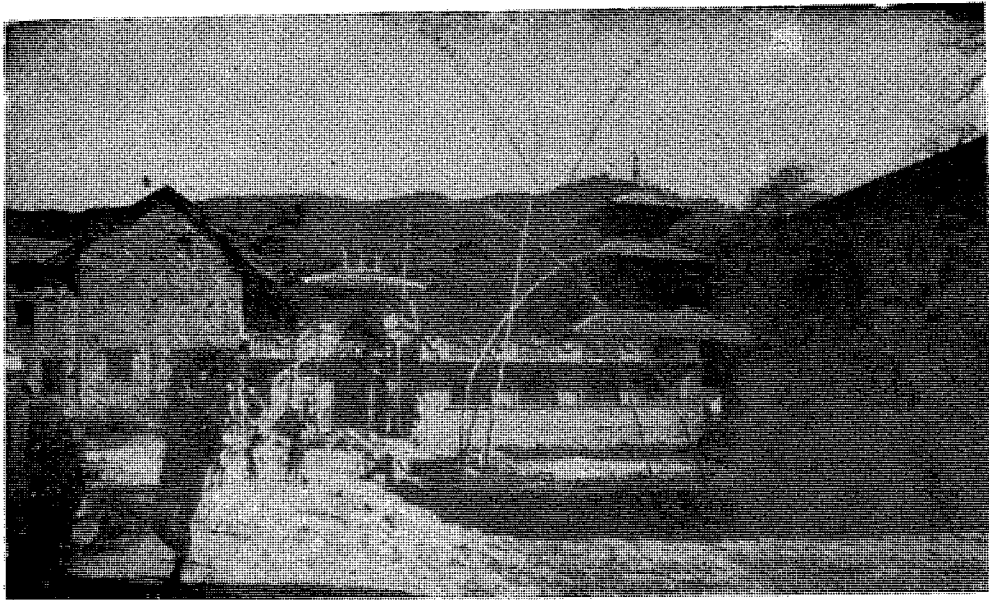
*New entrance and surrounding building*
