**Nepali-Italian Archaeological Sites and Monuments Excavation
and Restoration Project**

**A) Royal Palace ("of the 55 windows"),
Durbar Square, Bhaktapur**

PRELIMINARY REPORT

Preliminary report on the first campaign for the preservation and study of the mural paintings in the Royal Palace of Bhaktapur

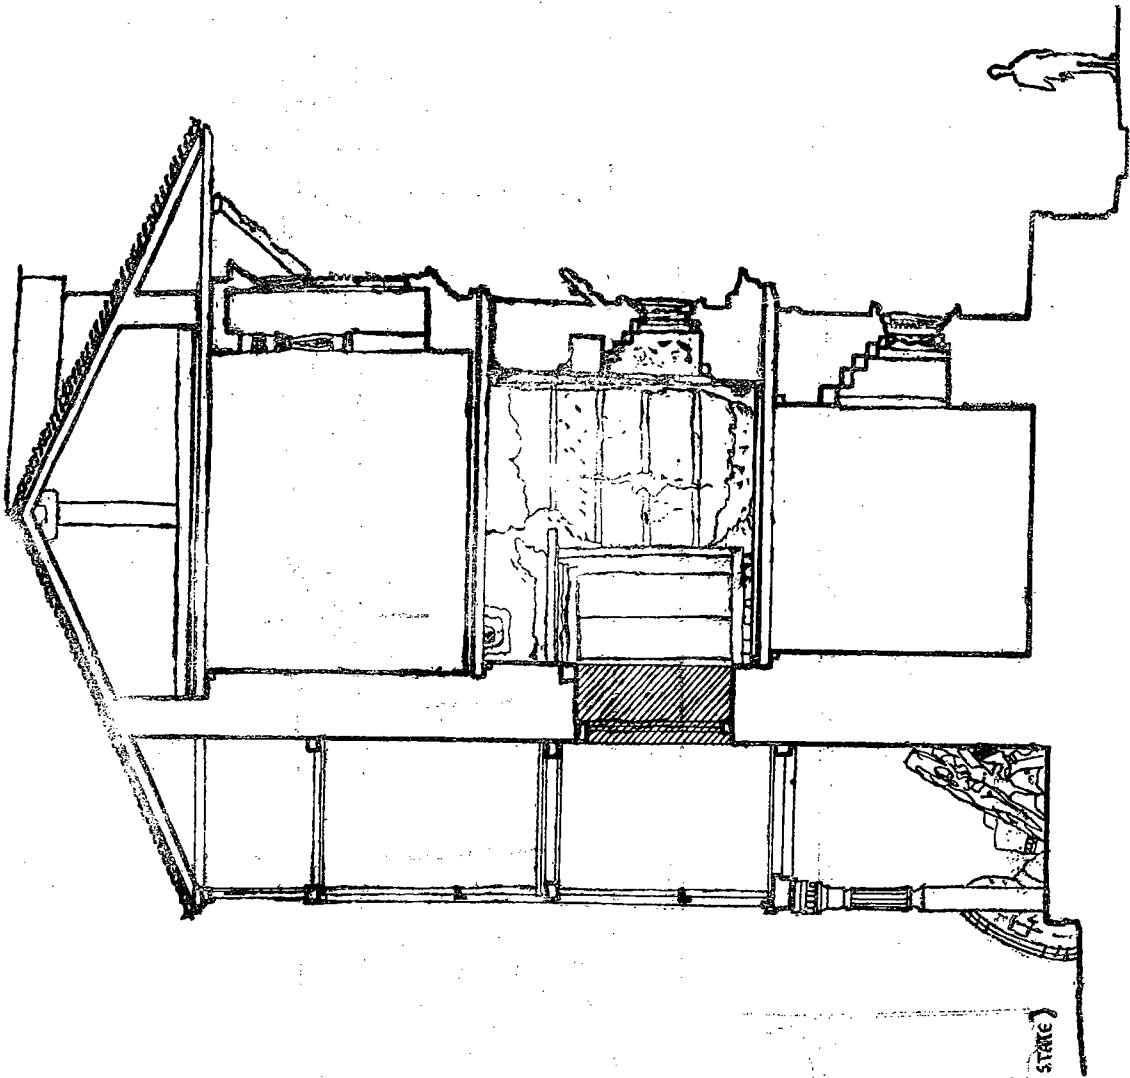
SECTION
(PRESENT STATE)

We have already mentioned the extensive damage caused by the various earthquakes, particularly that of 1934. The whole appearance of the square in front of the royal palace is quite different today, as many temples previously located there were not rebuilt. However, even prior to 1934 many of the internal courtyards or *chawk* around which the reception building were constructed had slowly disappeared. According to popular tradition they ranged in number from 12 to 99 (*sic*!), although only 6 are now identifiable and used (see fig. 1). The last earthquake also caused the collapse of much of the top floor of the Palace of the 55 Windows (the present gallery of the Museum of Wooden Sculptures with its characteristics continuous windows) together with the roofing. The top floor was completely rebuilt in past years, mostly using original materials.⁴ However, this did not prevent dangerous rainwater infiltrations from badly damaging the underlying murals. The whole of the outer wall of the middle floor (the one housing the paintings) has rotated some ten degrees towards the exterior, dragging the roof rafters with it (see section in fig. 3).⁵ This unhappy static condition was only worsened

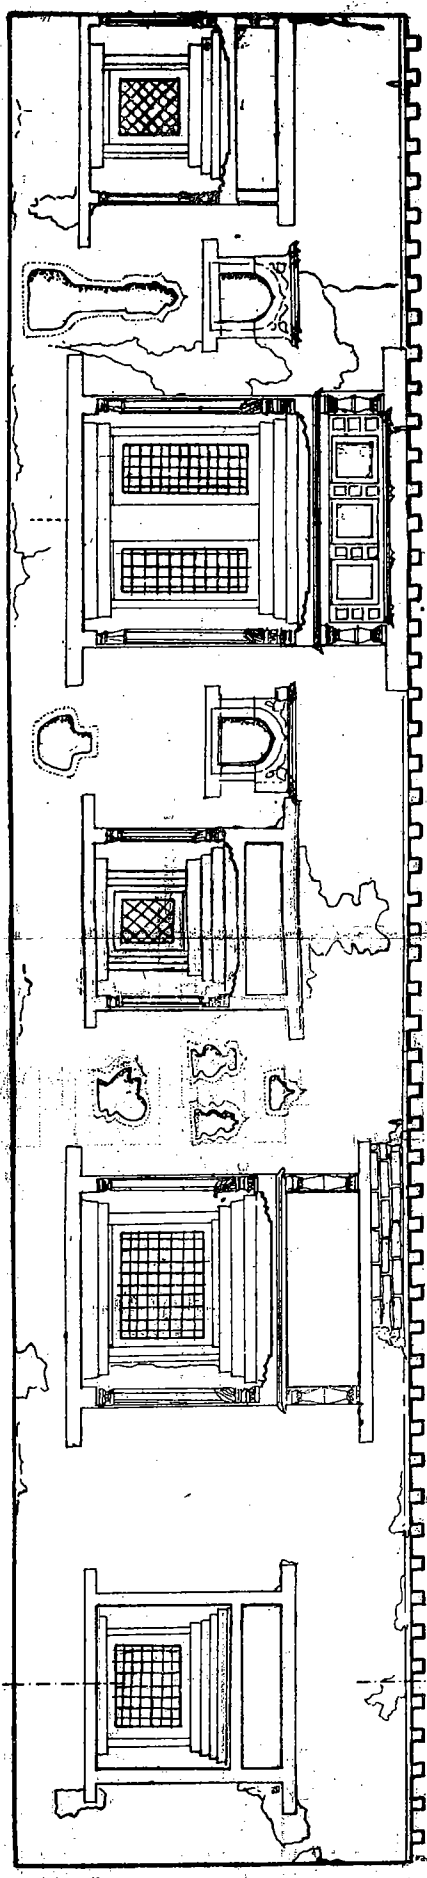
SOUTH WALL INTERNAL ELEVATION - 1:25 638

The S wall has an inclination towards the exterior of about 10 degrees, which means an approximately 5 cm gap at the top. Work was begun on fixing the falling layer of plaster and on removing the old cement patches. In this area the plaster has crumbled badly, again because of the water infiltrations. Also the S wall has suffered the same type of damage, and large sections of plaster are also missing. The wooden window frames are in a very bad state of repair in many places. Where the woodwork joins the plaster edge has come away in most places and has either fallen or is still hanging in situ. In the south and southwest zones, the remaining portions of pictorial layer are extremely small. The plasterwork applied to the lower part of the room is higher here (about 50 cm) and covers the lower frieze, wherever the latter still exists, up to and including the last inscription. The same is true of the window jambs.
