Ramagrama Excavation II

- Sukra Sagar Shrestha

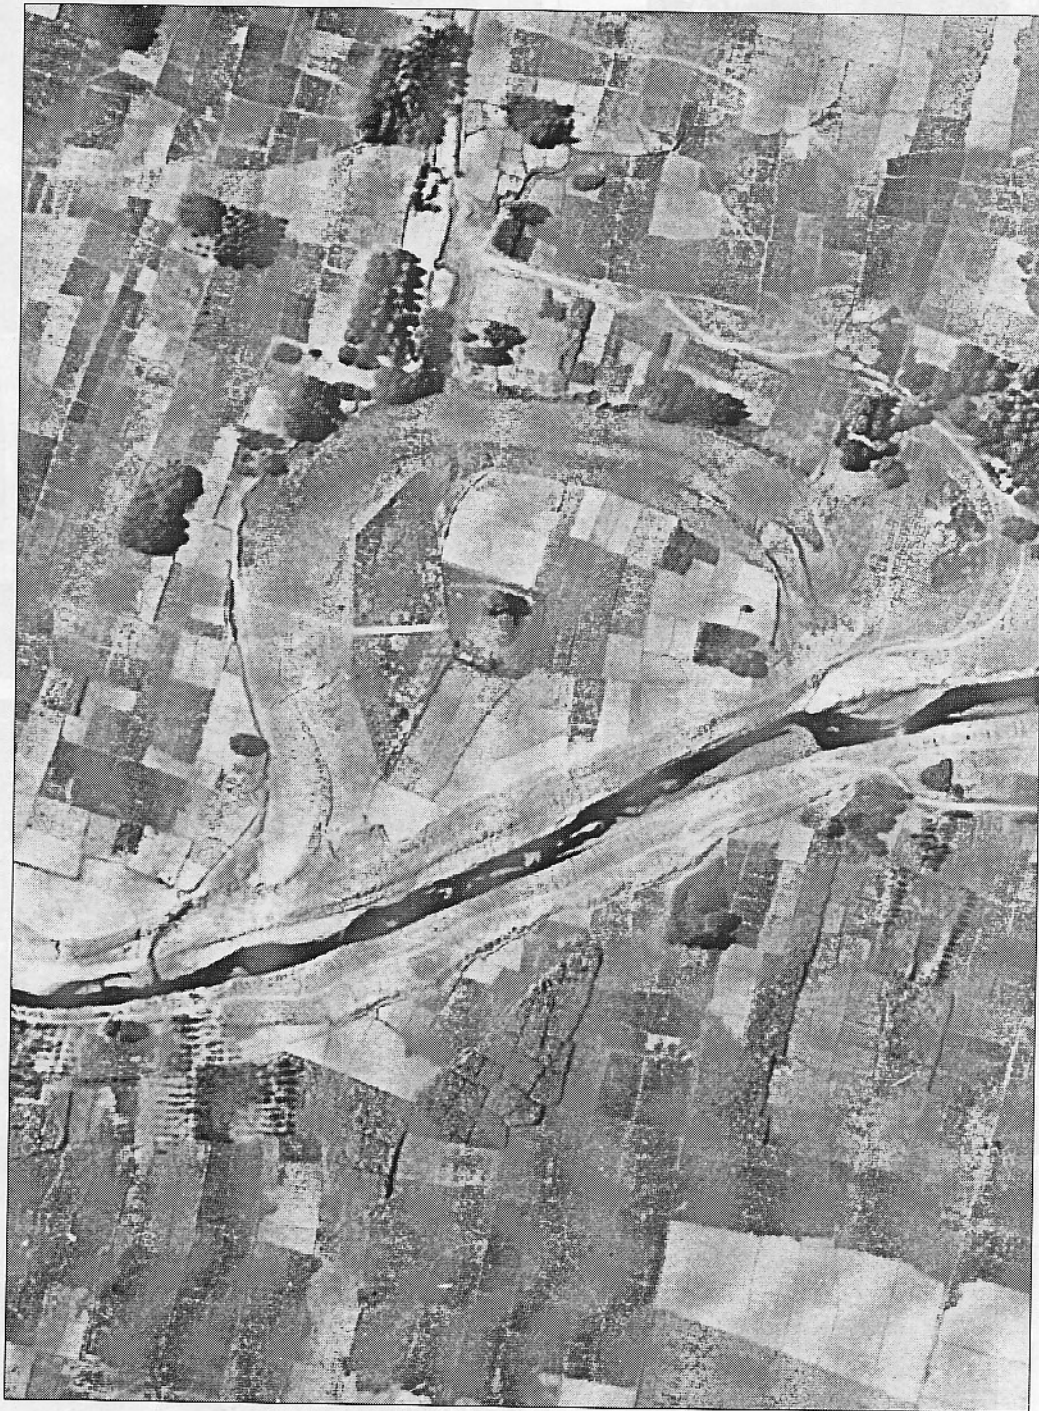
I. AERIAL VIEW OF RAMAGRAMA STUPA AND RIVER JHARAHI

stupa in 1986/87. Before that the stupa was surrounded by that river from three sides e.g. North, West and South. Once the river was diverted, the stupa complex then changed into an island topography. The running river Jharahi flows in the east and dried old course of the same river on all three remaining sides. But still a small strip of land is left on North as a land bridge. (Pl. I)

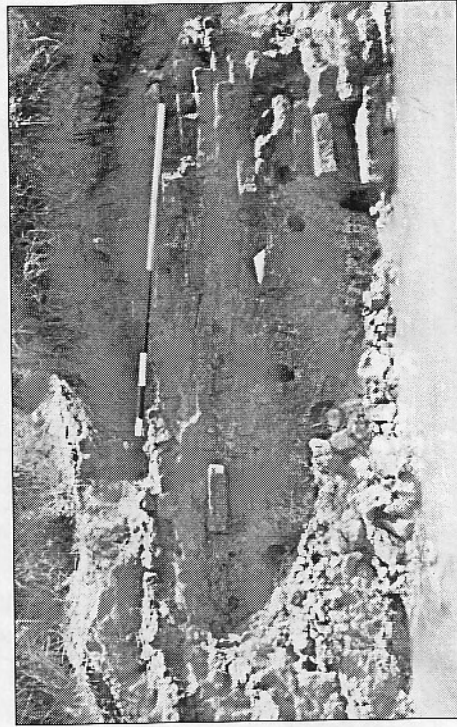
d. Wall structure exposed in river section to the east of the stupa

The site was thoroughly checked this year and found that the alignment has six courses of the bricks left. To the right angle of it in south, a wall of 50 cm thickness runs towards west. This portion of the wall is found cut and thrown away during the diversion act of the river.

A further dig to the east of the same spot would be fruitful to reveal the full structure in order to understand about the site. (PI IV d)

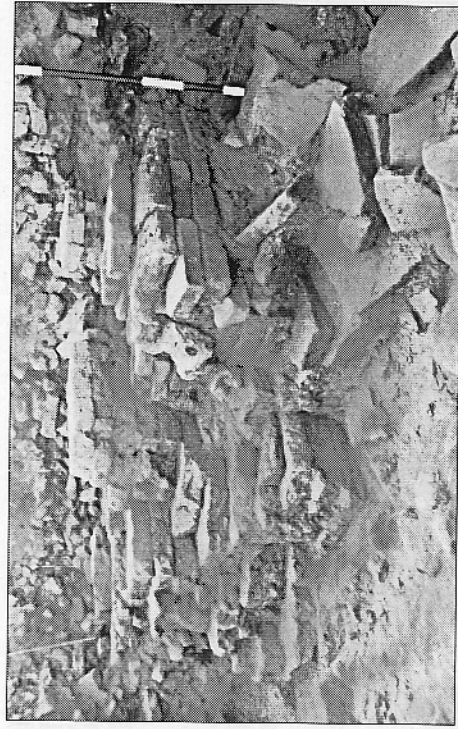
a. b. Mouryan wall and supportive structure in west of stupa

From the exposed structures in trench no 44 Ak and 44 Bm we can locate different phases of the stupa. The Mouryan structure is found to be tilted outwards and the second phase gave the supporting wall in west of which a piece is also found exposed in the trench 44 Aa. This phase could be from Sunga Kushan or even Gupta period⁶. (PI V ab) The size of the Mouryan bricks are found to be 7 x 27 x 38 cms quite identical to the same phase of construction in Mayadevi temple of Lumbini. The size of the wall is still unidentified within stupa because it goes towards the centre. Only next seasons digging will give this picture.

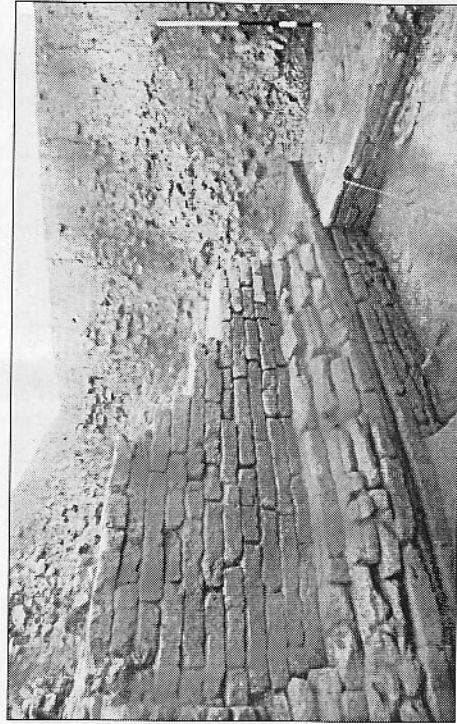
d. Mouryan structure in east of the stupa

This year's excavation (2001 AD) brought to light the Mouryan structure of the stupa. The structure was touched at the end of the excavation season. Therefore could not be gone down to foundation level. However the plinth could be exposed in west and East showing the Mouryan structure to be little more than thirty three meters in diameters.

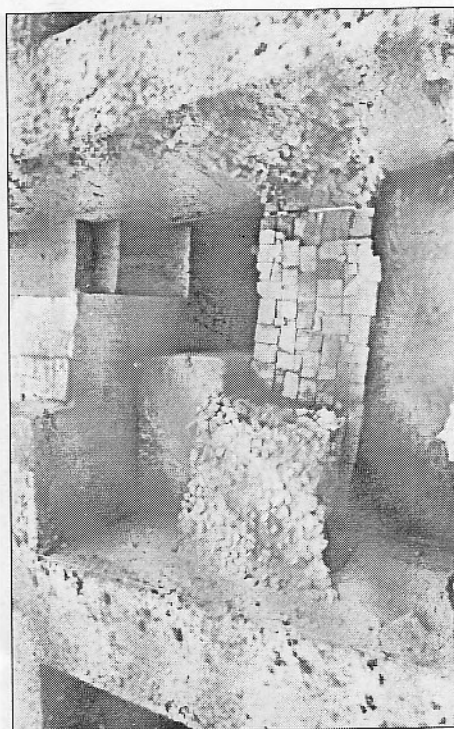
c. Inner wall foundation of the monastic complex in west

Unlike in outer walls, the inner walls of the monastic complex is nearly all robbed away leaving only seven courses of bricks in western side (Pl. VI c) where as in north three layers of the bricks are left in sporadic condition (tr. 35 Cg) and in south also

For more details of the composition-the eastern facade of the inner wall in the monastery is refilled with brickbats again because not a single brick was left in this part of the wall. All the bricks were taken out and filled with brickbats when the wall was robbed. The northern and southern part of the inner wall has partly original bricks up to five courses but that is also in western half only. Eastern halves of the walls were totally robbed away and remains in the form of ghostwall only. The western wing has complete wall still with seven courses of bricks left. This is the original part of the wall and bricks used on that part has more of the complete bricks. No brickbats are found used on that part of monastic wall (PI VIc)

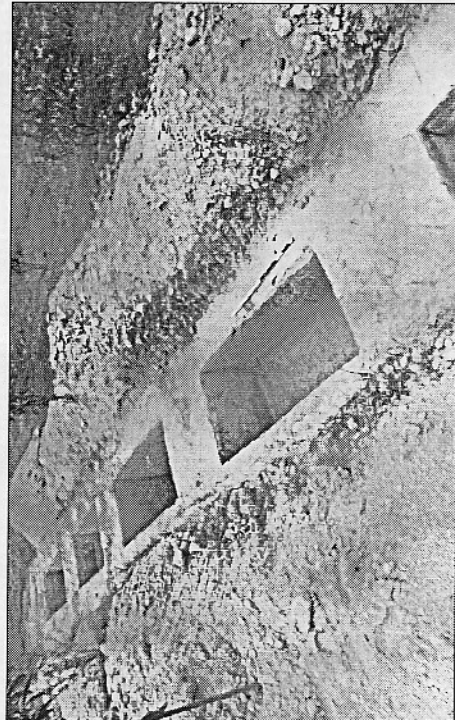
d. A trial trench in garden area.

laid in different parts of the garden. Two trenches of one and half meter by ten meters in west, two one by ten meters and one two by five meters at the center was laid down. On the east of the garden again, one two by five meters and one by thirty meters trenches were cut down. The depth in all the trenches were achieved to two meters down. Nothing except the reverse side silt is encountered. This part of the land is found to be sterile of the monuments underneath (PI VII d)

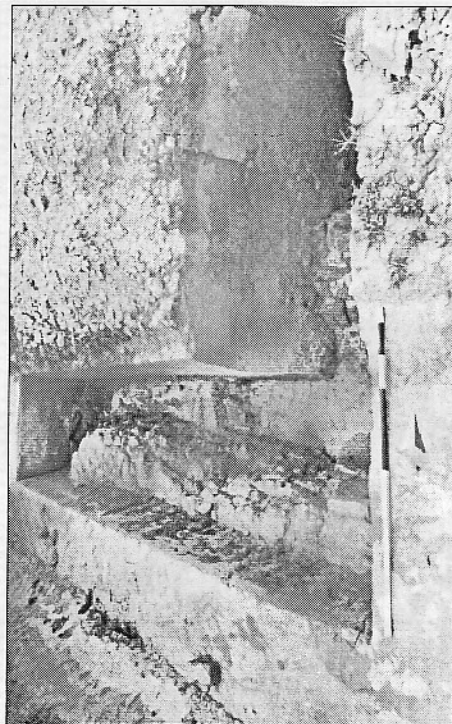
c. A trench in south of the stupa in old river course

After going down for one and half meters, it was found only fallen bricks in two of the eastern trenches while in western trench a clear alignment of brick wall is traced. Therefore this trench is extended towards north again with the size of one and half by two meters. It falls due north of exposed wall in the river bed. The wall is found one meter sixty centimeters extended further north from the alignments which is below eighty centimeters from the present river surface. At the depth of two meters and ten centimeters the water table came up and further digging is stopped. (Pl VII C)

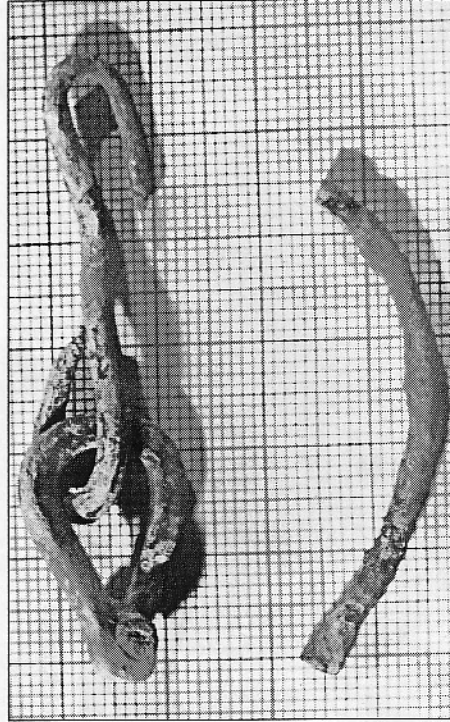
d. A door hook (?)

The location of the doors are not found with any tangible objects like door jambs and doorframes. But a door hook is found from the trench (pl IX d)

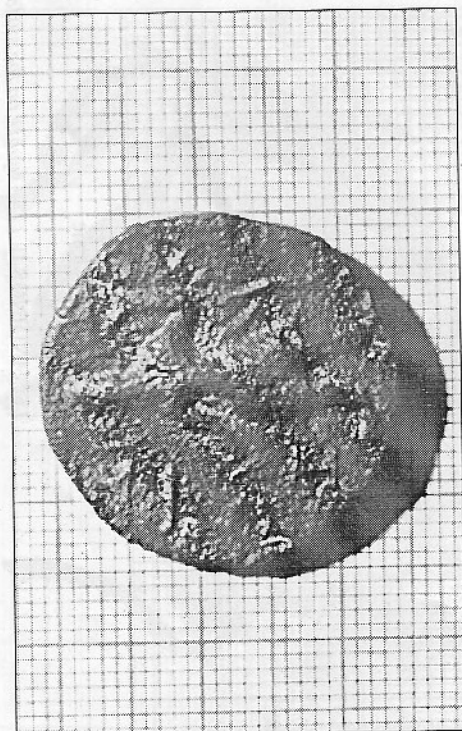
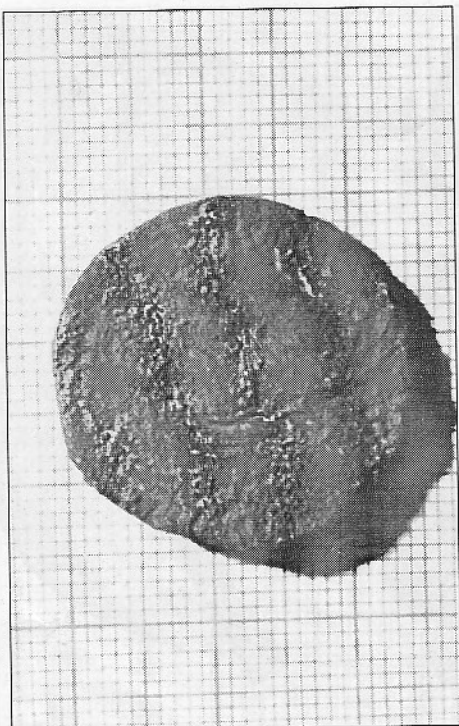
A copper coin of Kushan period

b. Reverse

a. Obverse

The size of the coin is 2.4 to 2.5 cms in diameter showing not in perfect circular shape. Similarly the thickness also varies from 2.4mm to 4.2 mm. The weight is 13.010 grams.

The coin is of Kushana period. There is a figure of a king wearing long coat down to the knee. The posture seems in walking with the feet apart. The right hand holds a lantern (?) in bent posture as if raising little up and left hand is raised up to elbow holding arrow or some type of club. The head seems wearing a pointed cap.

There are four letters embossed to the right of the figure. The legend reads व र्ण ण य⁶. The letters are of Brahmi from the periodic phase of Sunga Kushana.

On the reverse of the coin, there is a figure standing at the center and few letters in unintelligible condition. This side is much rusted therefore could not be deciphered properly. Such coin type was also reported from Tilaurakot coin hoards excavated by Risso University. Babukrishna Rijal has classified that under Buddha type copper coin of Kaniska⁷.

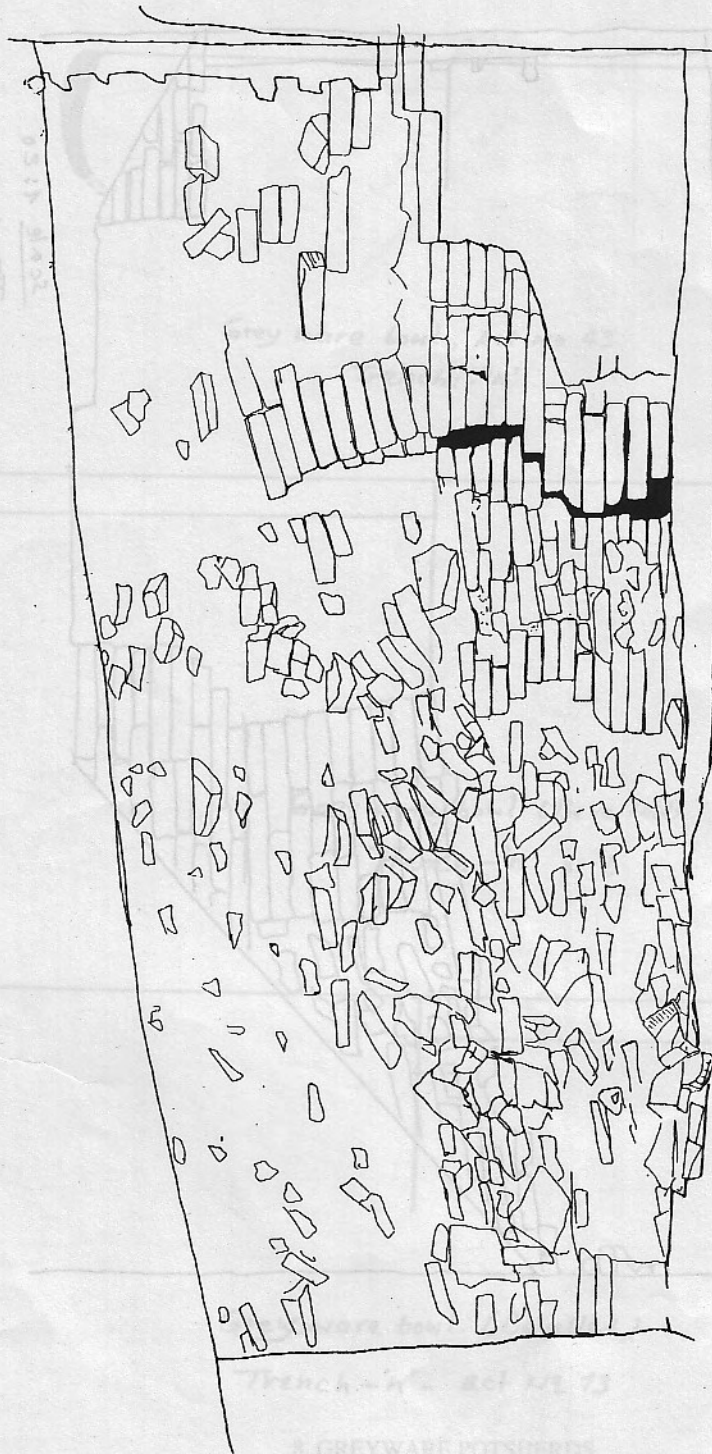
6. TWO PHASE OF MAIN STUPA STRUCTURE (WEST)

AAK.
- dit - dit
Half section in
Graded wall
1:70 scale

Two phases of wall
Maurian and Kushan (?)

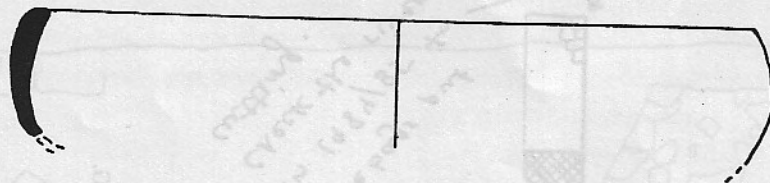
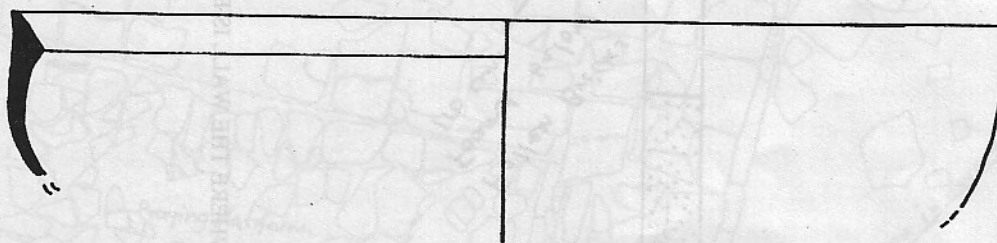
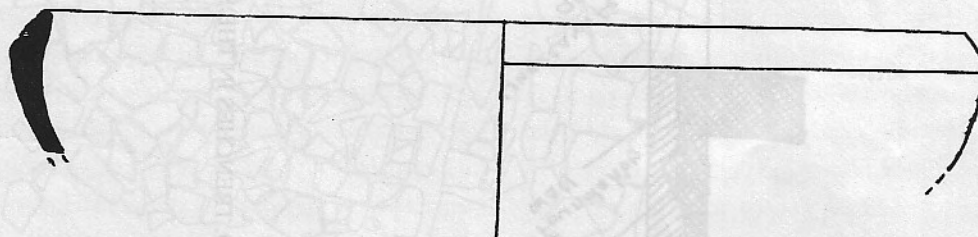
8. GREYWARE POTSHERDS

Grey ware bowl, Act no 43
Trench:- 'h'

Grey ware bowl (Bevelled)
Trench - 'h' or 'i'

Grey ware bowl (Bevelled)
Trench - 'h' - act no 13

The greyware potsherds are seen mostly from utensils than from other big pots. The edges of the gray ware are found bevelled either from inside or from outside. Knife edge bowls also are noticed. (Fig 8)
