Important Archaeological Sites of Devadaha Village

- Ram Bahadur Kunwar

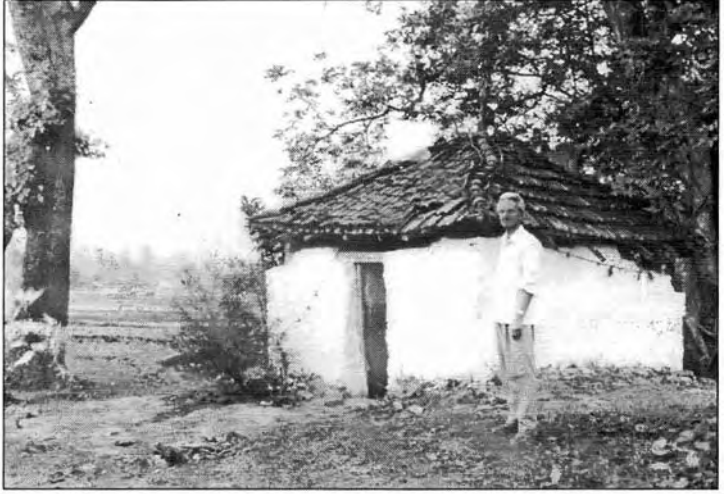
Photo No. 1

Kanyamai is located 1 kilometer on the south of village development committee office of Devadaha village. It is situated on the bank of a small rivulet which flows from north to south direction. There is a small mound of a ruined temple on which small temple can be seen on the top (Photo no.1). This site stretches from south to north and is surrounded by

paddy fields on the north and south. On the west there is a small vertical ditch which is used as paddy field. Some sal trees can be seen sparsely around the site. The main mound is a debris of huge stone pieces. They are there in large number and make one to guess that there might have been a temple which was fallen down in the past by some natural calamity. The stone pieces have been elaborately carved out with different motifs. There can be seen brick structure on the south of the mound which might have been built after the collapse of the stone structure. Moreover, there is a small ditch which was dug by the layman of the near by village to get treasure. The bricks are same as that from Sainamaina. So, the structure of Sainamaina and this site seem to have been built in the same period. Monolithic huge long pillars can be seen from the east side and few columns have been laid down on the center of the small rivulet. Few pottery are also found around the site which testify that there might have been a big village some time in the past. Inside the temple there are a lot of images. Among them the image of Lokeshwara is important (Photo No. 2) which has been executed in the standing posture with two hand, holding lotus flower in one of his hand and another is broken. The crown is also decorative. Hair style is simple. The height of image is 48 cm. and breadth is 28 c.m. Simple earrings, necklace and waistband can be seen on the image. The image seems little complicated and similar to those of the images of Pala period in India. Beside the image of Lokeshwara, small fragments of icons are also there which are not possible to be identified. The images which have been installed inside the temple were collected from the different part of the village in the past. The original places of the images are not known. But the style of the images proved that there might have flourished a great artistic tradition in the past in and around the area. The mound is being cut by a small rivulet gradually. Therefore, there is an urgent need of protection to save this site. The site is also being damaged by human activities and their encroachment. Last year Department of Archaeology,

His majesty's Government of Nepal fenced the site by barbed wire and with the help of Lumbini Development Trust the area of this site is also demarcated.

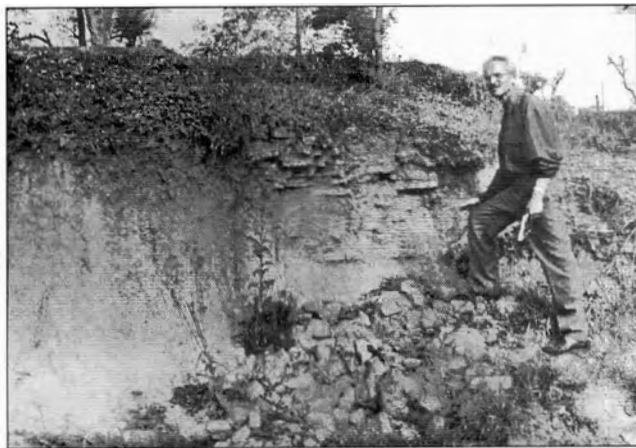
Photo No. 3

Bairimai is also an important site of Devadaha village development committee, which is situated on the north-west bank of Kairani khola, flowing north to west direction (Photo No. 3). This site is stretched to south north and fenced by barbed wired by the local people with the financial support of Lumbini Development Trust few year ago. The mound is raising gradually west to north. The Kairanikhola is cutting slowly the south part of the mound. It can be said that the mound is a debris of medieval temple. In 2052 V.S. the present writer got a chance to study this site along with his colleague. At that time he collected some decorated bricks from the bank of the river. The decorated bricks are very similar to those of the Kudan. So, the structure might have been built in the same time or little later. Dr. D.C. Regmi speculated that there might have been a big temple in the past, which had fallen or was destroyed by the human activities or natural disaster. There is the small roofed temple under which few images have been installed collected from different part of the village. Among them the broken image of Lokeshwara is important. The images are not in good state of preservation. All are broken. The styles, stone and posture of the images are similar to those of the images of Lokeshwara in Kanyamai.

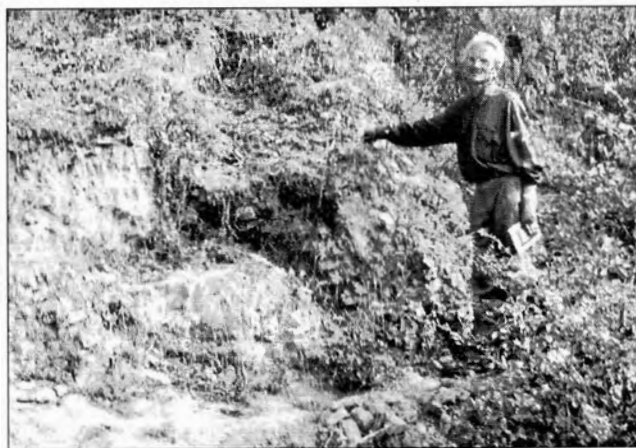
Photo No. 4

This site is located not far from the East West National High way near the village of Devadaha. The site is covered by the sal trees (Photo No. 4). It stretches north to south. East west length of the site is shorter than the north south. The site is very important for the archaeological point of view. Three important mound are seen in the middle of the site. All the mounds have been noted full of burnt bricks. The southern most mound is smaller than the other

and on the top it has been dug by the people that is why the mound is less safe than the other. Similarly the mound seems to be the ruins of temple. There might have been a temple in the past. The layman of the near by village regards the sites as a Buddhist monuments. The mound is being suffered by the encroachment problem. The south corner of the mound has been occupied by the migrants of hilly region. The another important mound is situated on the north corner of the site. It has been completely destroyed by the human activities. The people of the near by villages usually try to hunt treasure during night expecting valuable treasure left by their forefathers. The spade mark can be still seen there on the top of the mound. At present, the mound is sparsely covered with the sal bushes. This site also looks like a debris of temple. The burnt bricks of the site are similar to those of the bricks of Sainamaina and Kudan. The structure clearly elucidates that there might have been a temple at this place in the medieval period and this area seems to have been in the dominion of Sen of Palpa. It can be presumed that on the east of the site there was a small village in the past. The wells, bricks fragment, icons and various structures which existed around the village clearly make a ground to presume that there was a developed village where people built buildings. The fragmented images in these temple were scattered in the different part of village and seems later collected and deposited there. Then people started to venerate them and worship.

If we analyze the surrounding subtly then only truth will come out. The third mound lies very near to the south corner of the second mound. Small pieces of burnt bricks are scattered around the mound. The small path, which has been built recently, has damaged the east portion of the mound. This is also the foundation of a small temple, which rises upward slowly. This mound might have connection with the mound of the south corner.

Khayardada, which seems very important for archaeological research where people used to come for sectarian practice in the past. This site is safer than the other existed sites around the village. There is no problem of encroachment by the people from west,

north and east but the south corner is being suffered by encroachment problem. So there is the need of a barbed fence to stop human activities around the site. Last year the team consisting the officials of LTD and DOA demarcated the site from all direction. The icons, burnt bricks and pottery, which are found on the ground, seem to be the work of 15th or 16th centuries A.D. So the sites are not older than the 15th centuries A.D. To reveal its real history the site is waiting the tools of an archaeologist.
