BROKEN SHRINES: SIKKIM'S MONASTIC HERITAGE AFTER THE EARTHQUAKE

CHETAN RAJ SHRESTHA

1.1 SCOPE OF THE REPORT

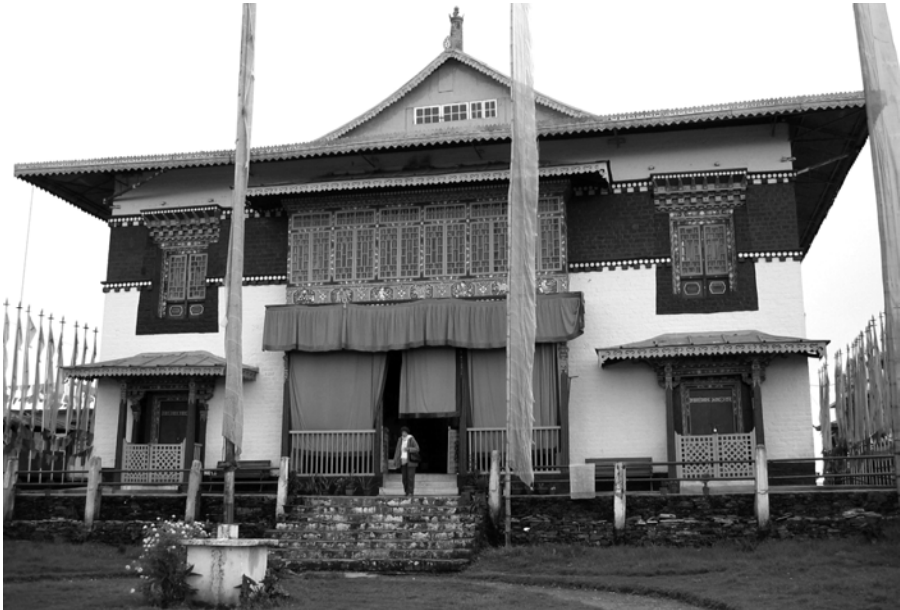
Pemayangtse Monastery, West Sikkim (Photo – Anna Balikci)

Pemayangtse was one of the first examples of a concrete frame being used on an old monastery. In 1960, Sir Tashi Namgyal, then Chogyal funded a restoration/expansion program at the monastery. This was a

sensible strategy as it used the existing building and worked around it. Concrete, perhaps because of its scarcity, was used sparingly. Later projects have refrained from such understanding. Many old monasteries have been dismantled and rebuilt in concrete, such as Tashiding, Phensang, Phodong and more recently, Tholung.

RCC: The effects of age on RCC monasteries cannot be determined as most of the RCC monasteries are fairly young, dating to after 1975. One of the earlier known RCC interventions was at Pemayangtse in 1960. It does not show signs of stress due to ageing.

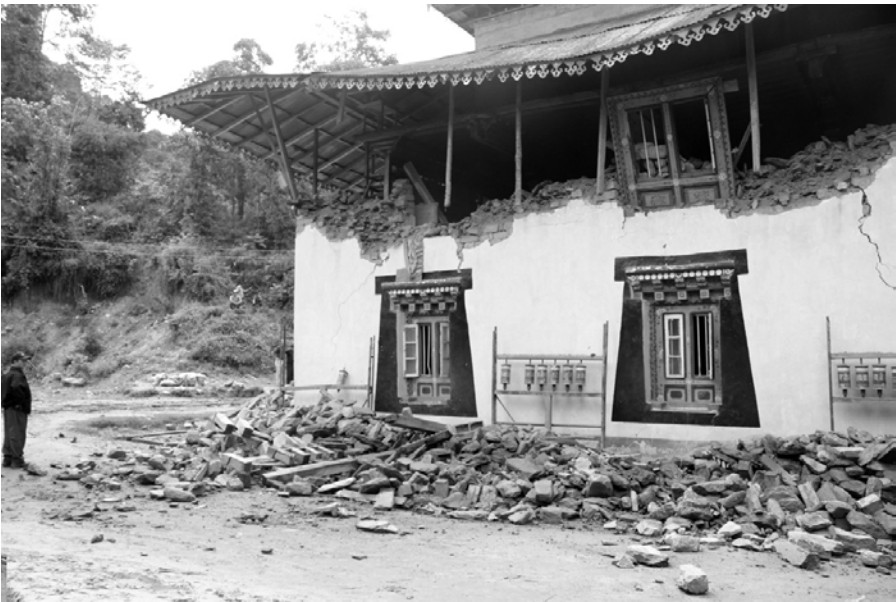
- i. Lachung Singring Monastery (RCC)
- ii. Tholung Monastery (RCC)
- iii. Chungthang Monastery (*ekra* and RCC)
- iv. Chungthang Mani Lhakhang (RCC)
- v. Lachung Monastery (RCC)
- vi. Chawang Monastery (masonry)
- vii. Phamtam Monastery (RCC)
- viii. Menrang Monastery / Mani Lhakhang (masonry)
- ix. Ringhim Monastery (masonry)

Ringhim Monastery, North Sikkim (Photo – Sikkim Now!)

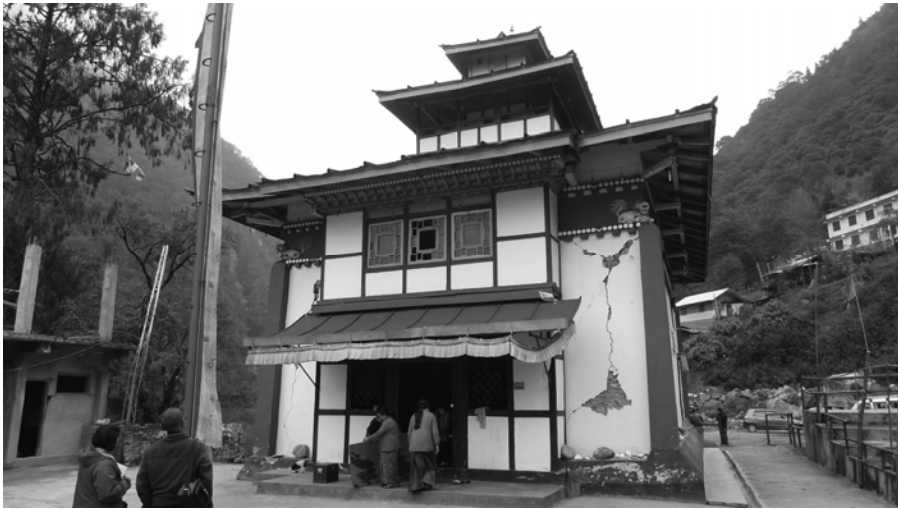
Chungthang Monastery, North Sikkim (Photo – Rajendra Desai)

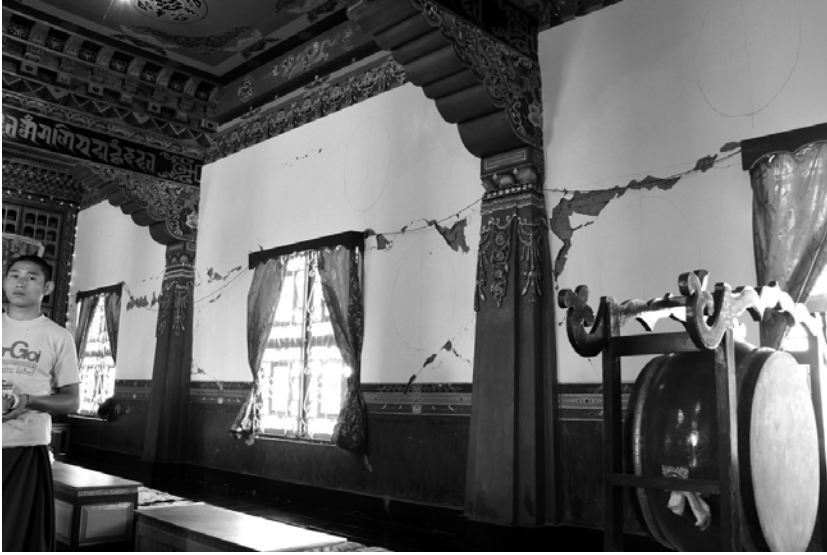
- i. Rey Mindu Monastery (RCC)
- ii. Old Rumtek Monastery (RCC)
- iii. Khamdong Monastery (RCC)
- iv. Rongey Mani Lhakhang (masonry)
- v. Tirkutam Monastery (RCC)

Rey Mindu Monastery, East Sikkim (Photo – S T Gyatso)

Other monasteries which have shown major subsidence are the ones at Rey Mindu, Pemayangste, Ralang, Mangru, Phamtam and Lingdum.

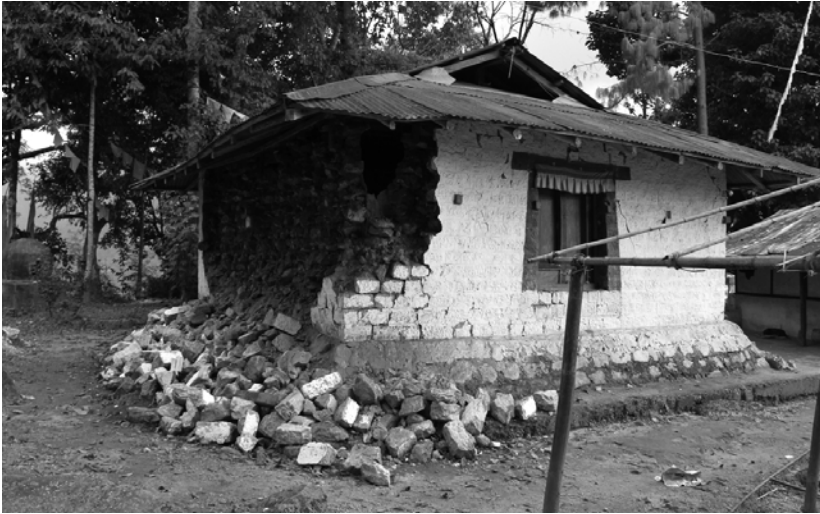
Rongey Mani Lhakhang (Photo – S T Gyatso)

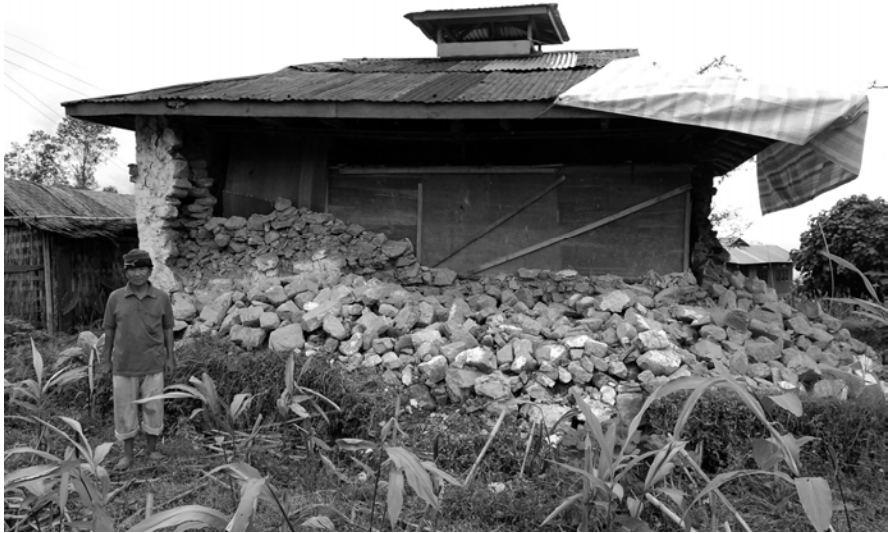
- i. Pemayangtse Monastery (composite)
- ii. Khechuperi (masonry)
- iii. Hongri Monastery (masonry)
- iv. Dubdi Monastery (masonry)
- v. Tashiding Monastery (composite)

Khechuperi Mani Lhakhang (Photo – Suraj Rai)

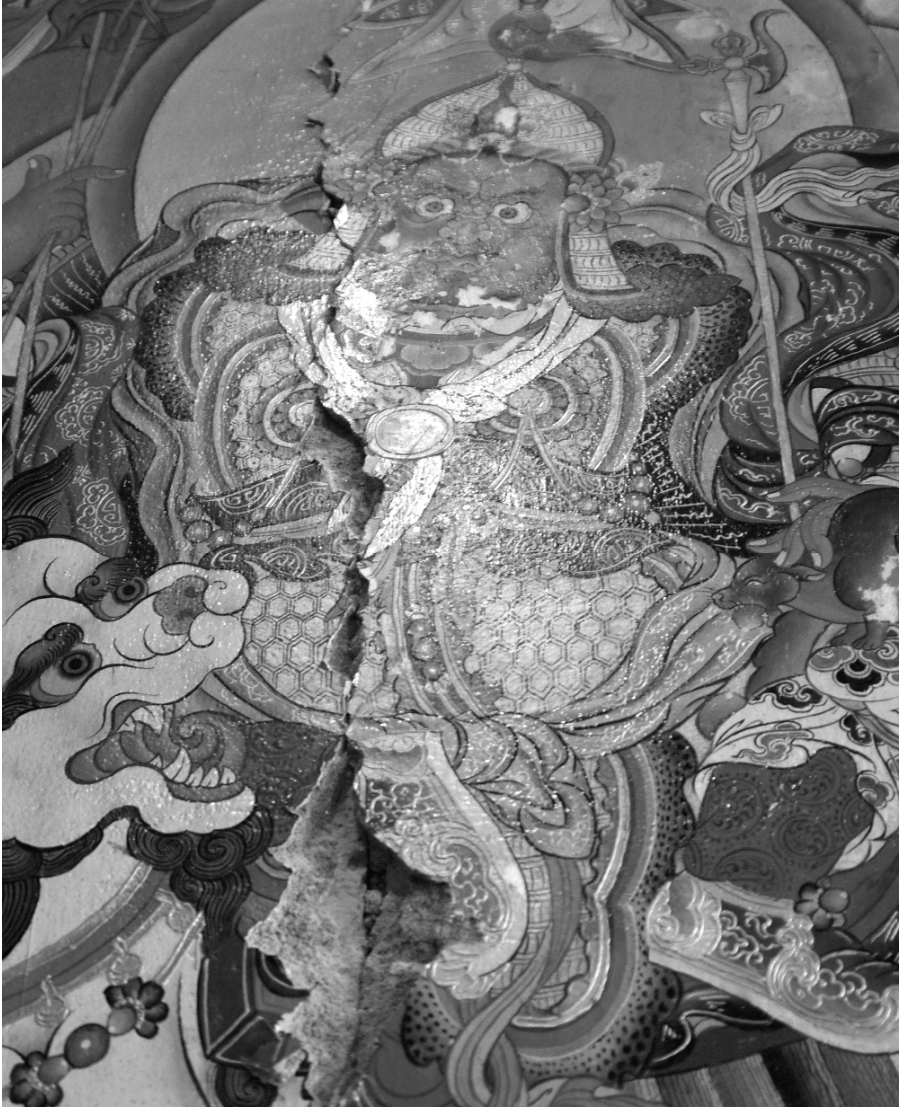
- i. Ralang Monastery (RCC)
- ii. Jorethang Monastery (RCC)
- iii. Samtenling Monastery (masonry)

Ralang Monastery interior, South District (Photo – Author)

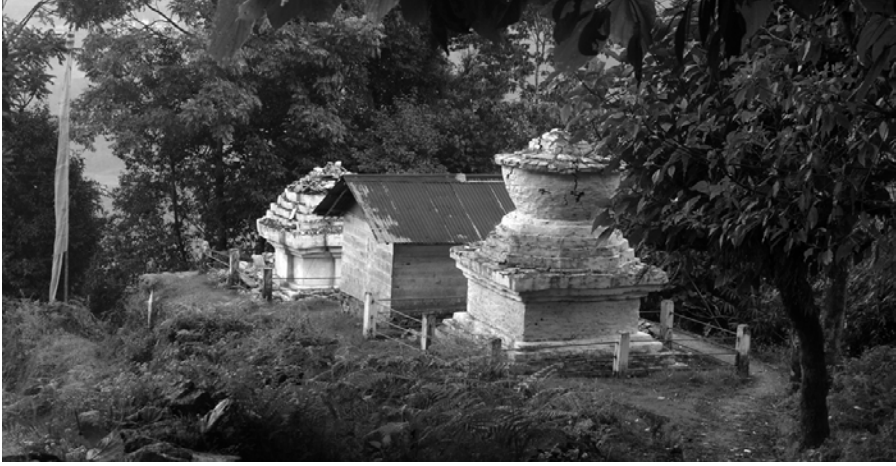
There has also been substantial damage to the innumerable *chortens* and *mendangs* that are scattered across the state. The *chortens* and *mendangs* are masonry structures. *Chortens* tend to be inherently vulnerable to earthquakes because of their design, which comprises of a series of bellies and necks. Some of the notable *chortens* that have been

substantially damaged are the ones at Tumlong, which have great historical importance, Lachung (Thomchi Monastery), Khechuperi, Pemayangtse and Dubdi. The *mendangs* which have been damaged are Mangru Mendang in South Sikkim, Bichu Mendang in Lachung, North Sikkim, Khamdong Monastery in East Sikkim and Tashiding Monastery in West Sikkim.

The *chortens* at Tumlong (Photo – Author)

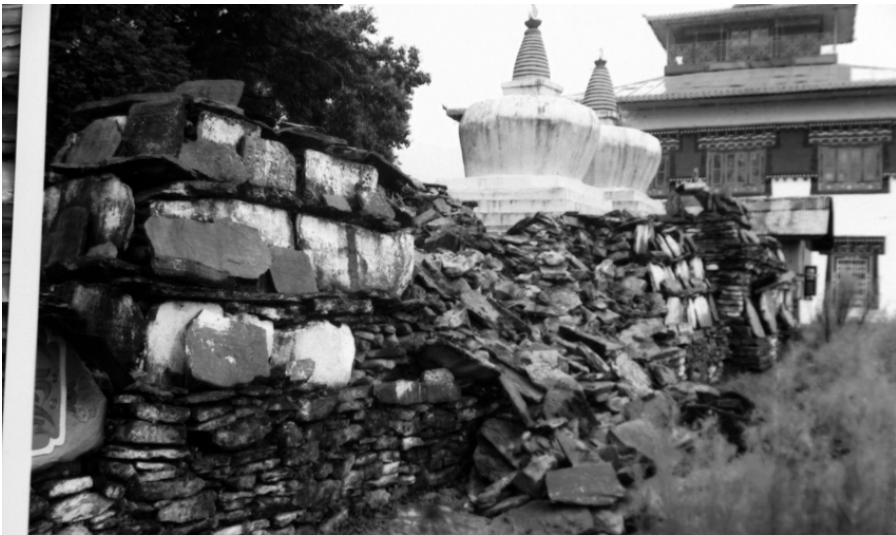
Tashiding Monastery *mendang*, West Sikkim (Photo – CA&HD)
