**Nepali-Italian Archaeological Sites and Monuments Excavation
and Restoration Project**

**A) Royal Palace ("of the 55 windows"),
Durbar Square, Bhaktapur**

PRELIMINARY REPORT

Preliminary report on the first campaign for the preservation and study of the mural paintings in the Royal Palace of Bhaktapur

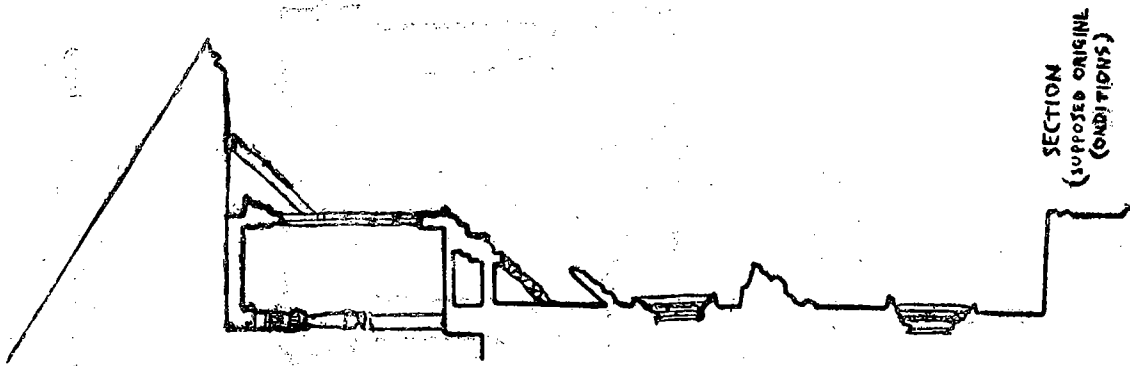
SECTION
(SUPPOSED ORIGINAL
(CONDITIONS))

We have already mentioned the extensive damage caused by the various earthquakes, particularly that of 1934. The whole appearance of the square in front of the royal palace is quite different today, as many temples previously located there were not rebuilt. However, even prior to 1934 many of the internal courtyards or *chawk* around which the reception building were constructed had slowly disappeared. According to popular tradition they ranged in number from 12 to 99 (*sic*!), although only 6 are now identifiable and used (see fig. 1). The last earthquake also caused the collapse of much of the top floor of the Palace of the 55 Windows (the present gallery of the Museum of Wooden Sculptures with its characteristics continuous windows) together with the roofing. The top floor was completely rebuilt in past years, mostly using original materials.⁴ However, this did not prevent dangerous rainwater infiltrations from badly damaging the underlying murals. The whole of the outer wall of the middle floor (the one housing the paintings) has rotated some ten degrees towards the exterior, dragging the roof rafters with it (see section in fig. 3).⁵ This unhappy static condition was only worsened

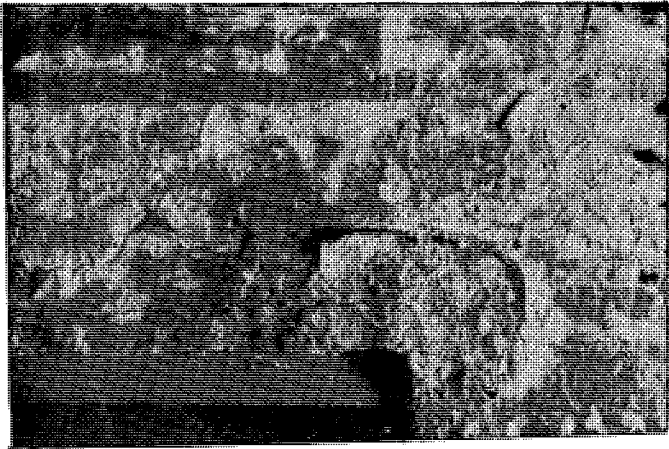
Fig. 3

A typical cross section through the axis of window n. 3 is shown in fig. 3.

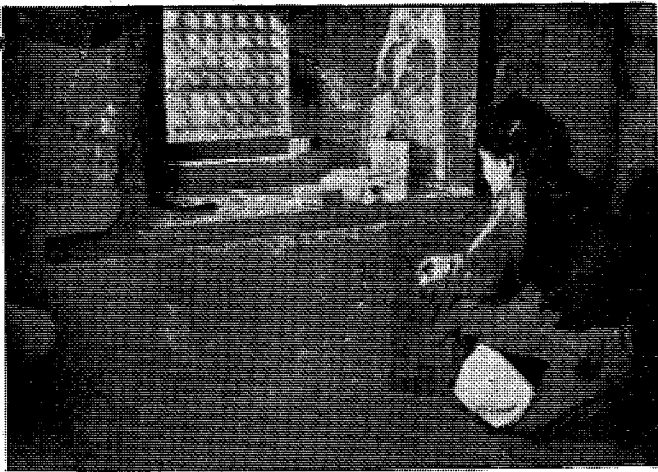
Fig. 4

In order to facilitate the identification of the various pictorial panels, particularly when the iconographic problem comes to be dealt with systematically, the four walls of room A have been represented schematically in fig. 4.
