ANCIENT NEPAL

Journal of the Department of Archaeology

Number 148

Ramagrama Excavation II

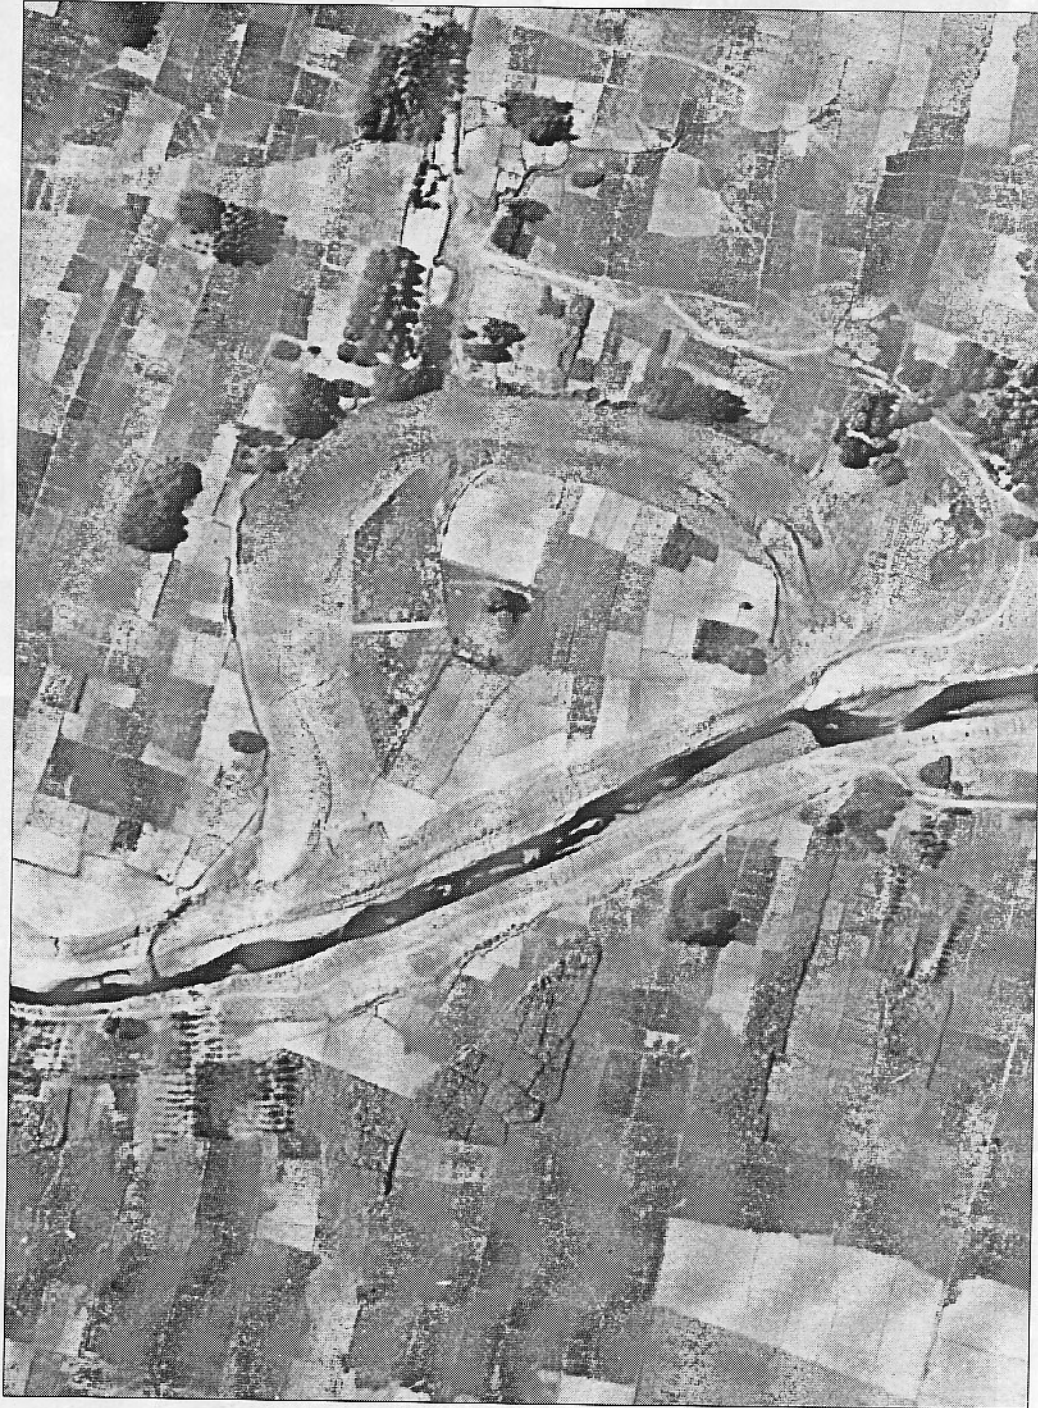
I. AERIAL VIEW OF RAMAGRAMA STUPA AND RIVER JHARAHI

stupa in 1986/87. Before that the stupa was surrounded by that river from three sides e.g. North, West and South. Once the river was diverted, the stupa complex then changed into an island topography. The running river Jharahi flows in the east and dried old course of the same river on all three remaining sides. But still a small strip of land is left on North as a land bridge. (Pl. I)

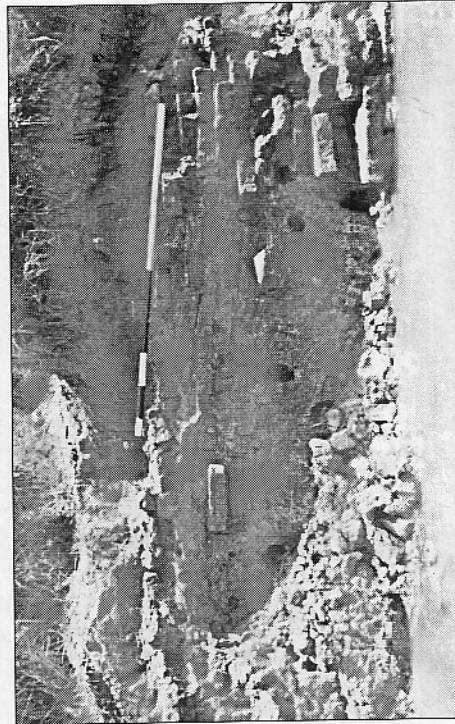
d. Wall structure exposed in river section to the east of the stupa

A small piece of the wall is found exposed in the left bank of river Jharahi to the east of the stupa. The alignment of it runs nearly for two meters in north south direction. The structure was unnoticed or neglected during the diversion act of the river in 1986/87. Archaeological value was underestimated, then.

The site was thoroughly checked this year and found that the alignment has six courses of the bricks left. To the right angle of it in south, a wall of 50 cm thickness runs towards west. This portion of the wall is found cut and thrown away during the diversion act of the river.

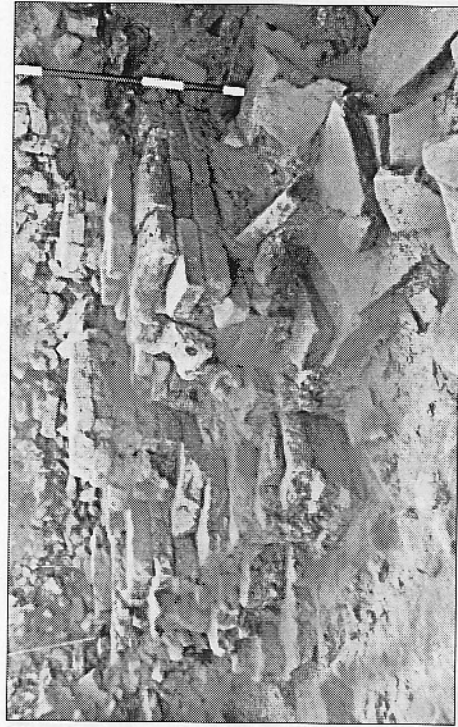
a. b. Mouryan wall and supportive structure in west of stupa

From the exposed structures in trench no 44 Ak and 44 Bm we can locate different phases of the stupa. The Mouryan structure is found to be tilted outwards and the second phase gave the supporting wall in west of which a piece is also found exposed in the trench 44 Aa. This phase could be from Sunga Kushan or even Gupta period⁶. (PI V ab) The size of the Mouryan bricks are found to be 7 x 27 x 38 cms quite identical to the same phase of construction in Mayadevi temple of Lumbini. The size of the wall is still unidentified within stupa because it goes towards the centre. Only next seasons digging will give this picture.

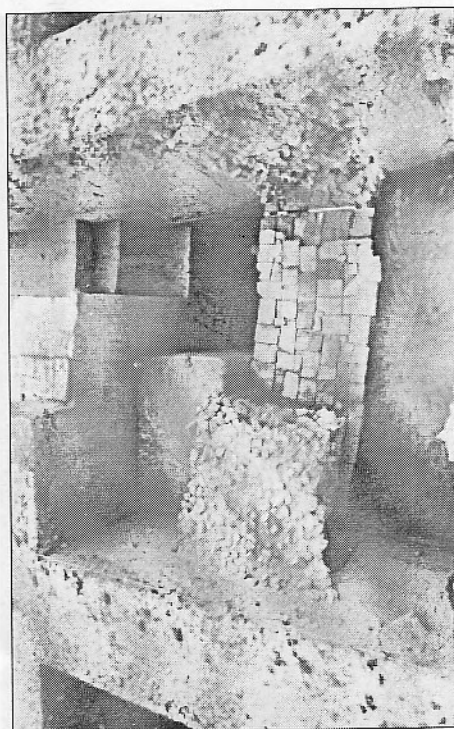
c. Inner wall foundation of the monastic complex in west

Unlike in outer walls, the inner walls of the monastic complex is nearly all robbed away leaving only seven courses of bricks in western side (Pl. VI c) where as in north three layers of the bricks are left in sporadic condition (tr. 35 Cg) and in south also

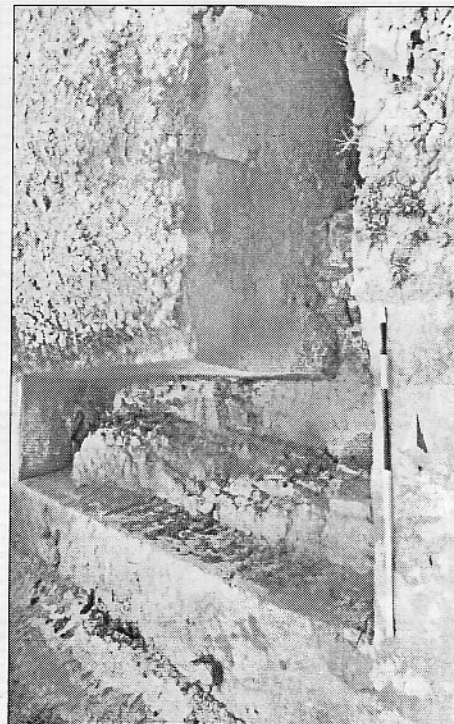
c. A trench in south of the stupa in old river course

After going down for one and half meters, it was found only fallen bricks in two of the eastern trenches while in western trench a clear alignment of brick wall is traced. Therefore this trench is extended towards north again with the size of one and half by two meters. It falls due north of exposed wall in the river bed. The wall is found one meter sixty centimeters extended further north from the alignments which is below eighty centimeters from the present river surface. At the depth of two meters and ten centimeters the water table came up and further digging is stopped. (Pl VII C)

From this cutting it is found that this part of the structure is found to be cut and buried by the river at least 2.5 meters. Since the river is already diverted now, there is no threat of being further destruction any more.

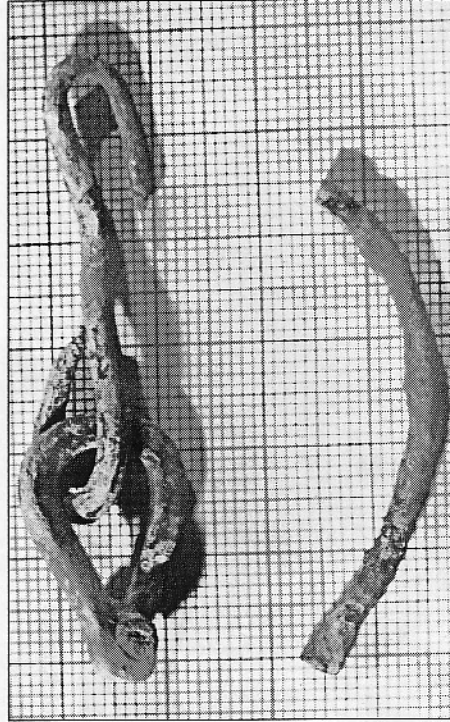
d. A door hook (?)

The location of the doors are not found with any tangible objects like door jambs and doorframes. But a door hook is found from the trench (pl IX d)

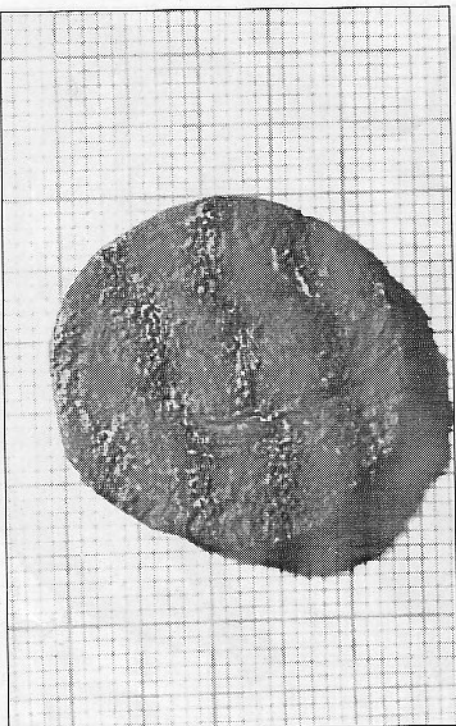
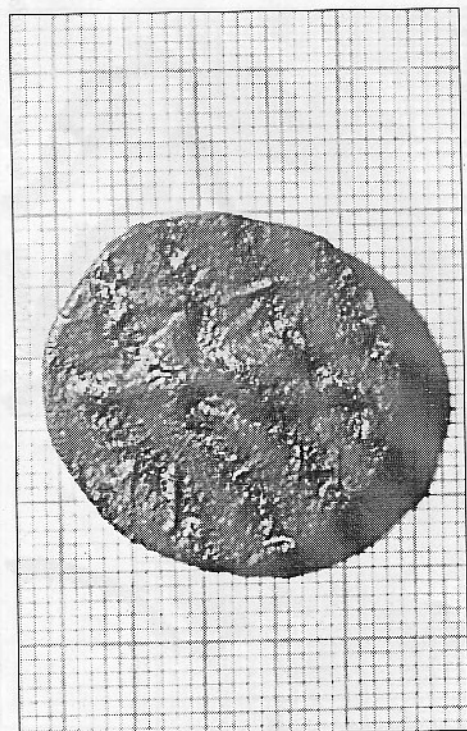
b. Reverse

A copper coin of Kushan period

a. Obverse

The coin is of Kushana period. There is a figure of a king wearing long coat down to the knee. The posture seems in walking with the feet apart. The right hand holds a lantern (?) in bent posture as if raising little up and left hand is raised up to elbow holding arrow or some type of club. The head seems wearing a pointed cap.

On the reverse of the coin, there is a figure standing at the center and few letters in unintelligible condition. This side is much rusted therefore could not be deciphered properly. Such coin type was also reported from Tilaurakot coin hoards excavated by Risso University. Babukrishna Rijal has classified that under Buddha type copper coin of Kaniska⁷.

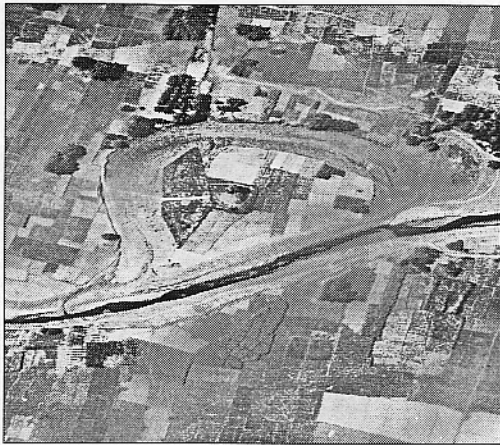
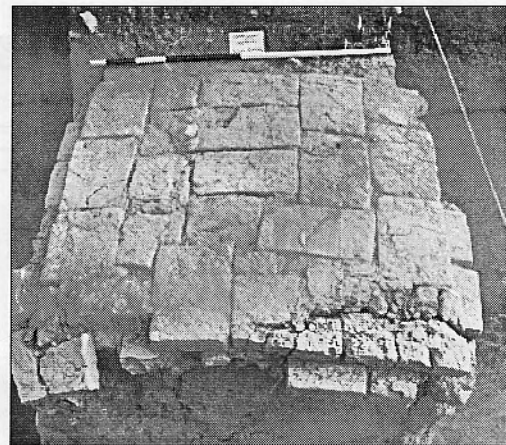
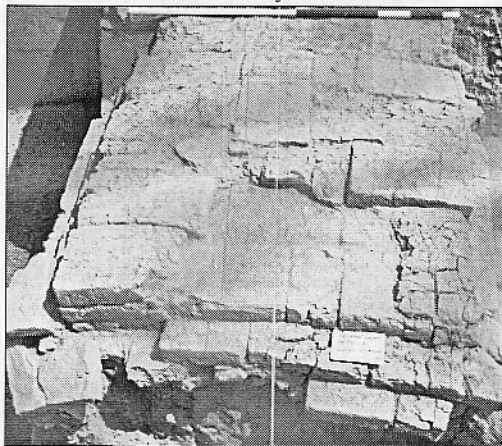
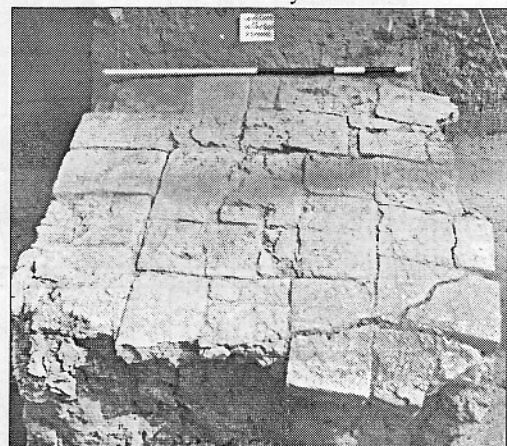
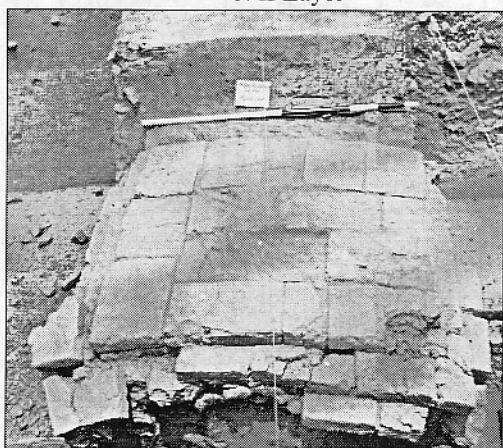
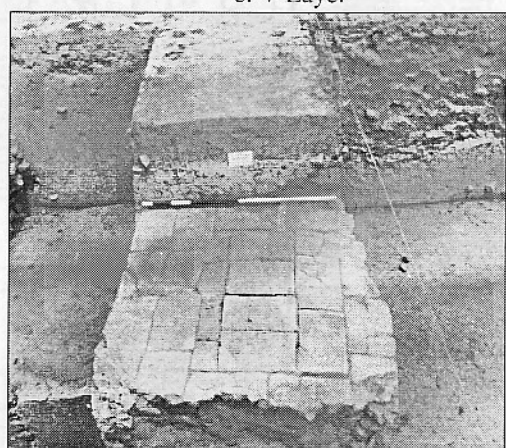
XI. CUTTING OF CENTRAL STRUCTURE INSIDE COURTYARD

a. I Layer

d. IV Layer

b. II Layer

e. V Layer

c. III Layer

f. VI Layer

There is a votive stupa erected at the centre of the courtyard. The placement of this stupa is little deviated towards southwest by 20 cms. The size of the courtyard is 4.80m square, exactly double the breadth of the monastic room-size. The stupa does not seem contemporary to monastic complex because the last flood occurred after the abandonment of the monastery and this votive stupa is found constructed on top of that last flood layer. The placement of the stupa seems chance placement at the center of the monastic courtyard. The stupa has six courses of bricks and seems erected from the salvaged bricks from surrounding (See Pl XI and Fig 5)

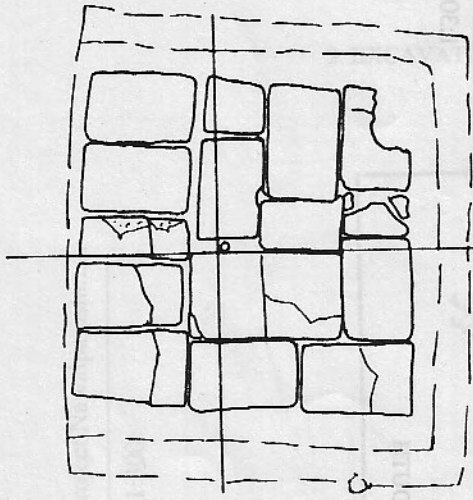
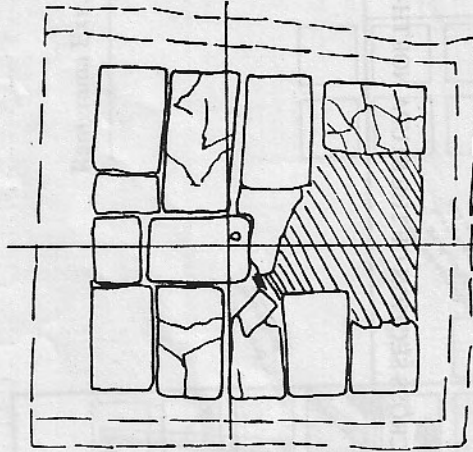
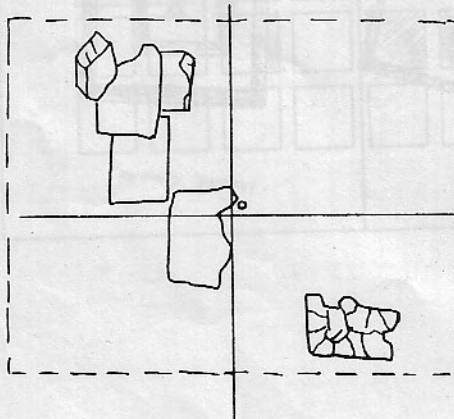
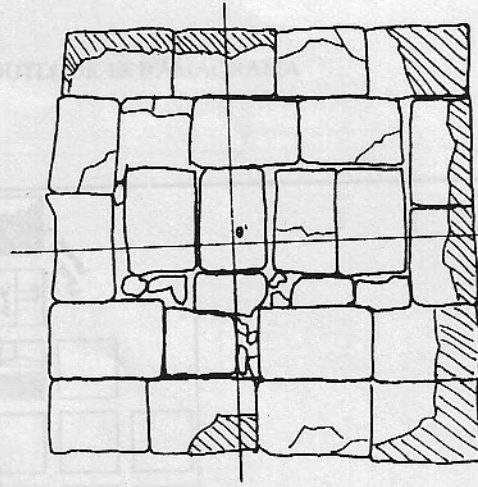
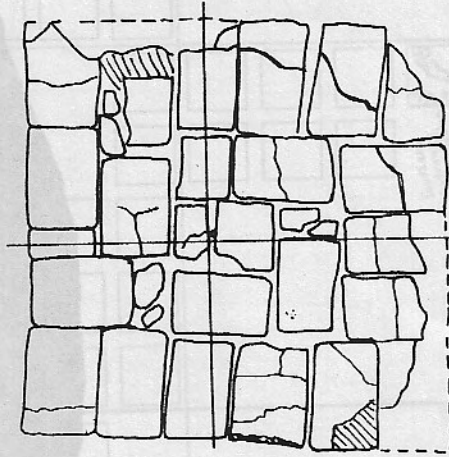
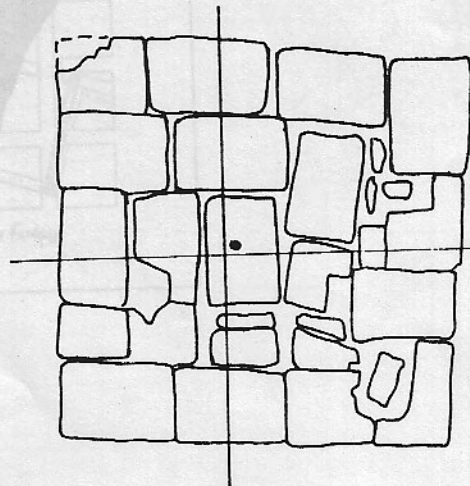
5. DIFFERENT LAYER OF BRICKS IN CENTRAL STUPA STRUCTURE.

c. IIIrd Layer of Bricks

b. IInd Layer of Bricks

a. 1st Layer of Bricks

f. III Layer of Bricks

e. V Layer of Bricks

d. IV Layer of Bricks

All the bricks used in this structure is found to be the size of 5 x 19 x 29 cms. The bricks are laid one upon the other in the pattern as shown in the drawing (Fig 5). The structure was laid collecting the full size bricks around the stupa well after the abandonment of the monastic complex. (see also p 4)

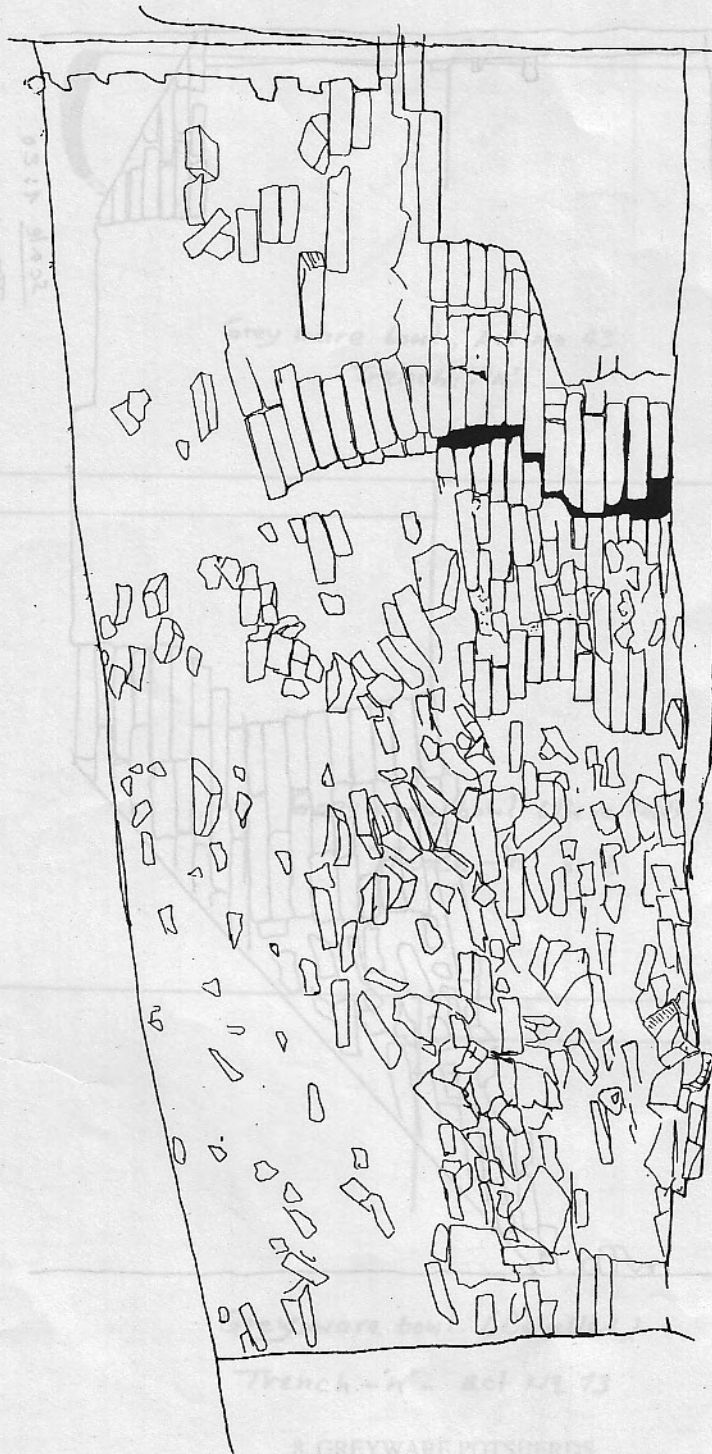
6. TWO PHASE OF MAIN STUPA STRUCTURE (WEST)

AAK.
- dit - dit
Half section in
Graded wall
1:70 scale

Two phases of wall
Maurian and Kushan (?)

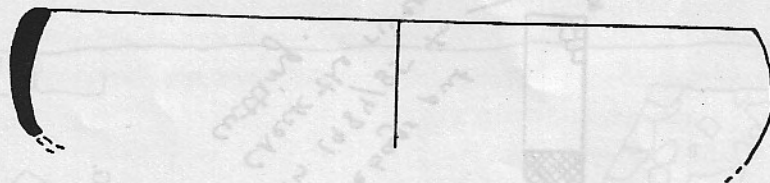
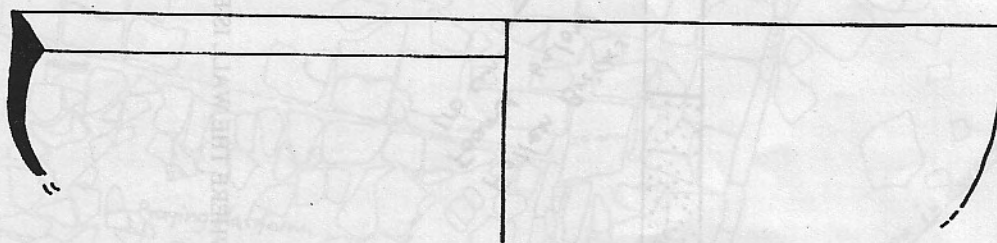
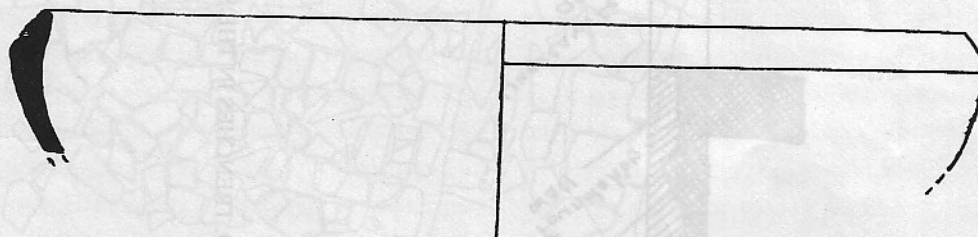
8. GREYWARE POTSHERDS

Grey ware bowl, Act no 43
Trench:- 'h'

Grey ware bowl (Bevelled)
Trench - 'h' or 'i'

Grey ware bowl (Bevelled)
Trench - 'h' - act no 13

The greyware potsherds are seen mostly from utensils than from other big pots. The edges of the gray ware are found bevelled either from inside or from outside. Knife edge bowls also are noticed. (Fig 8)

Unlike the other gray wares, the specimen from Ramagrama greywares are found dotted with some red spots showing some presence of brick grits. Therefore it could be surmised that the Ramagrama greywares may be of latter date (5-3rd century B.C.)

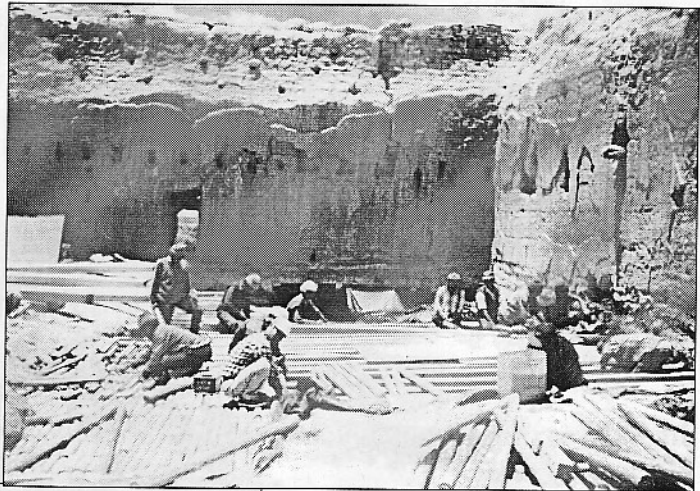
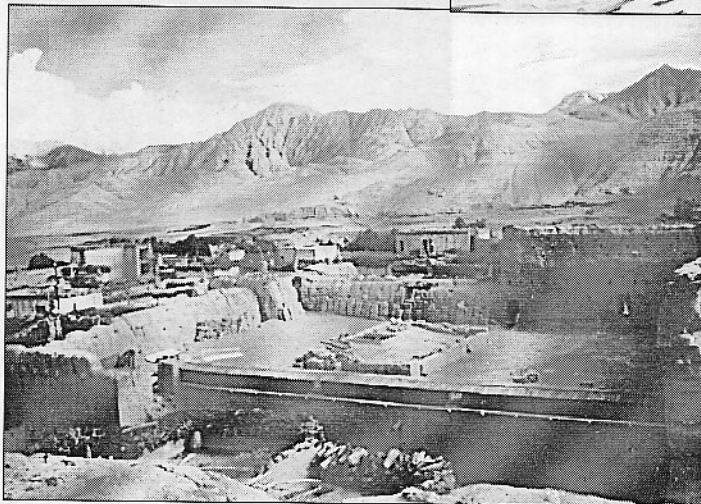
1. Roof repairing work in Thubchen Gonpa

2. Roof of the Thubchen Gonpa after repair.

- The whole roof structure was completely repaired. The deteriorated and damaged rafters and joists of the roof have been changed and covered again by stone and mud. The parapet around the roof was covered by stone.

- The skylight of the roof is modified. Before, there was light from the above section but now light enters from the south.
- The roof of the vestibule is repaired.
